City of Grand Prairie Supplemental City-Wide Drainage Master Plan for Fish Creek (Y#0882) Garden Branch, Kirby Creek, & Willis Branch

February 2013

Garden Branch Stream Condition Assessment

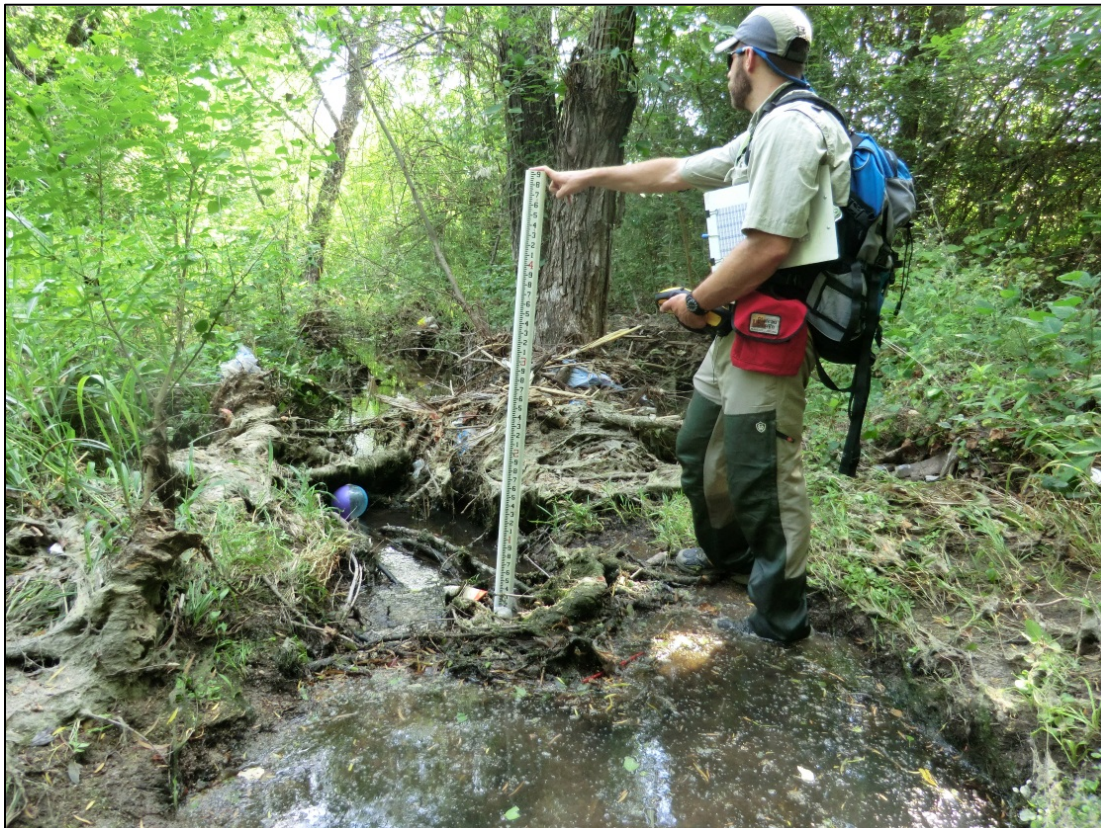
Figure 4.2 Looking downstream near cross section 6056 at a knickpoint with a 1.5-foot drop in elevation.

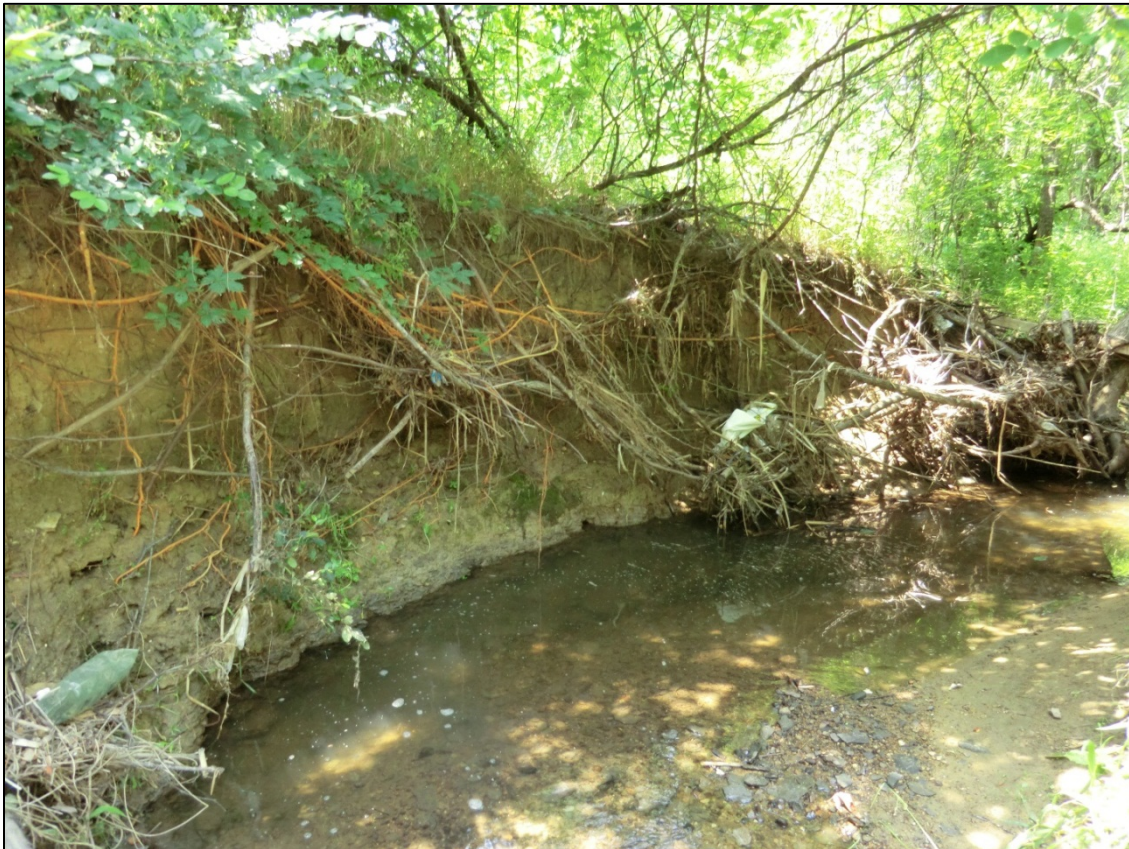
Figure 4.7 Looking downstream at severe bend scour near cross section 3177

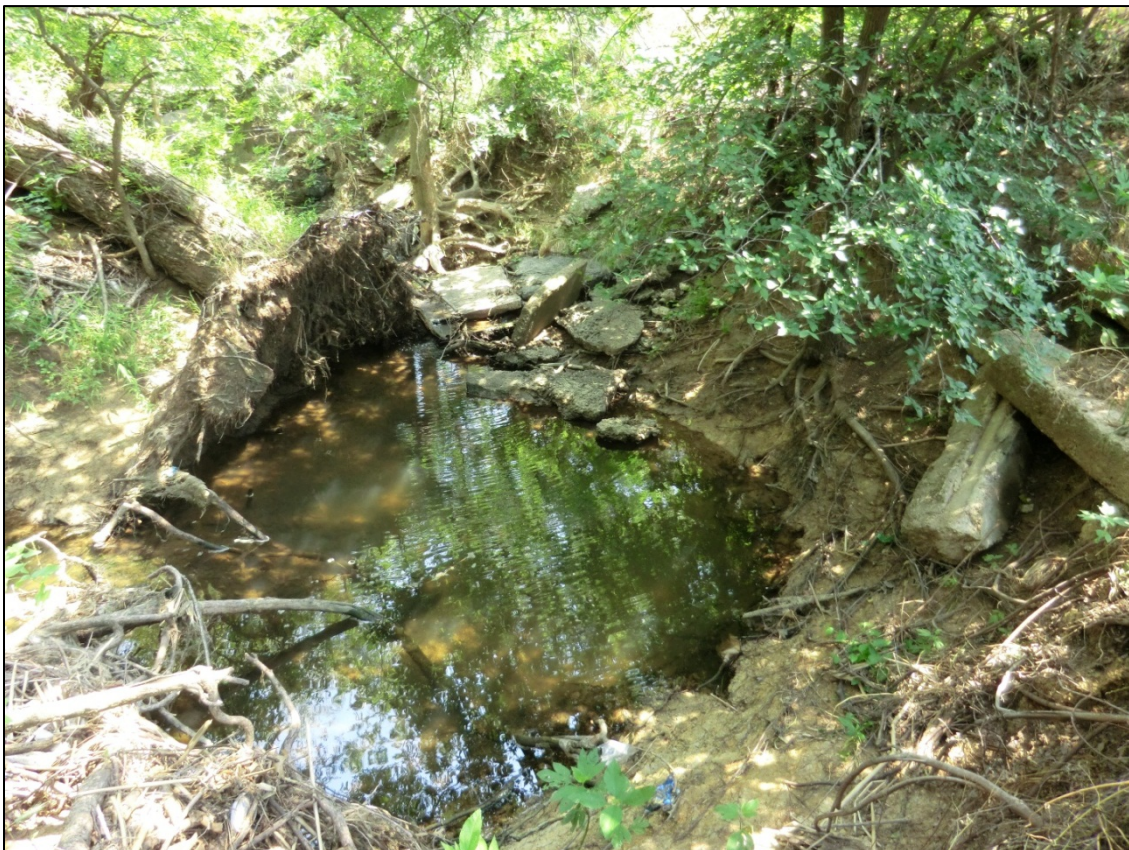
The second severe erosion location was near cross section 2496. This segment of channel contained a concrete low water crossing that protected a pipeline. The concrete crossing had a low flow outlet that was completely clogged. The blockage caused the water to pond upstream. Downstream of the concrete crossing the channel was severely scoured. The banks were collapsing, trees were falling, roots were exposed and the concrete structure was undermined from local scour (Figure 4.8). Water was flowing underneath the concrete structure.

Figure 4.8 Looking upstream at the undercut concrete crossing and severe erosion near cross section 2496

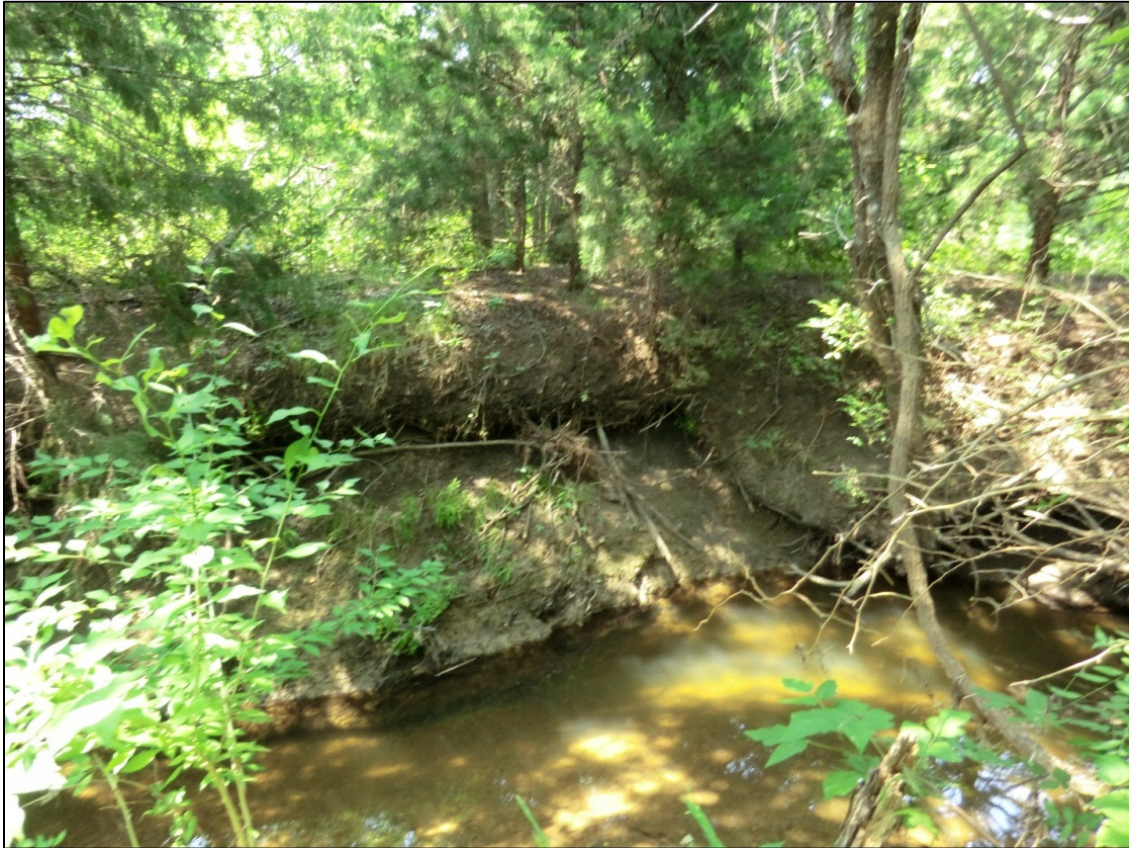
Figure 4.9 Looking downstream at a slump failure on the right bank downstream of the scoured concrete crossing near cross section 2496

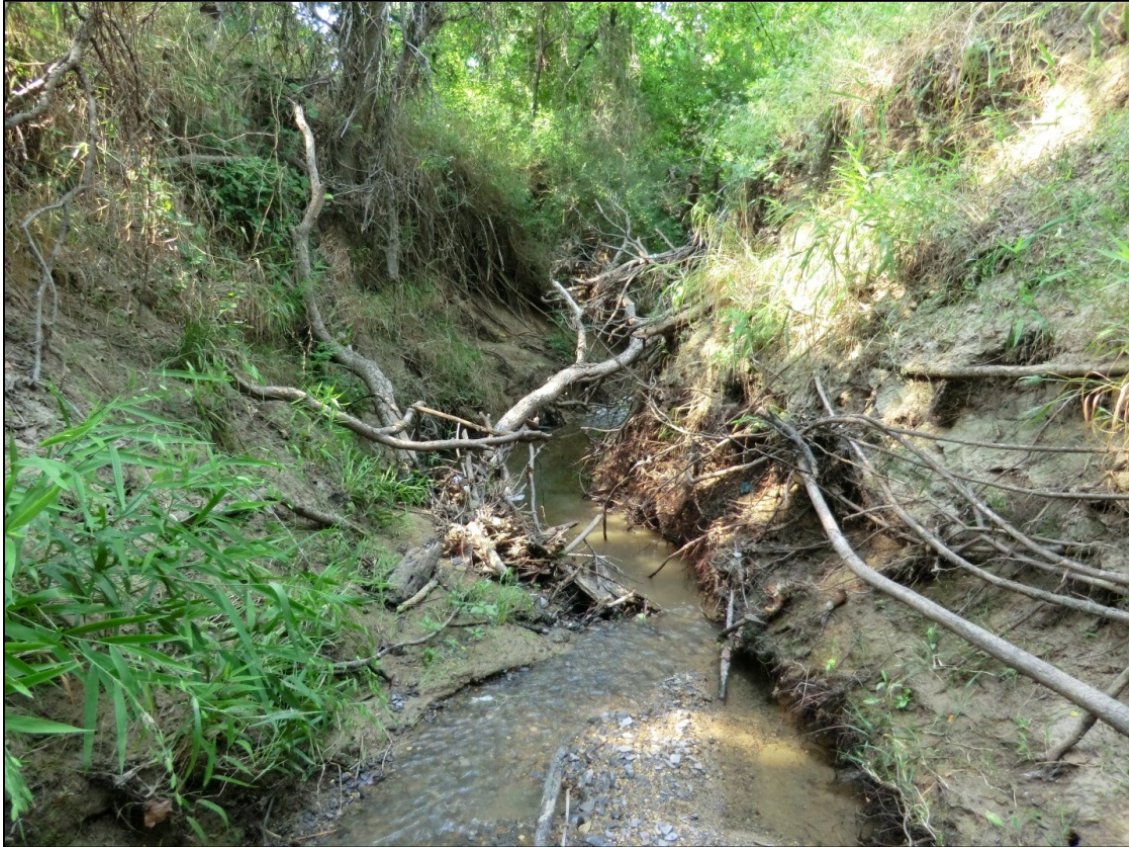
**Figure 4.12 Garden Branch was incised near cross section 289
(looking upstream)**

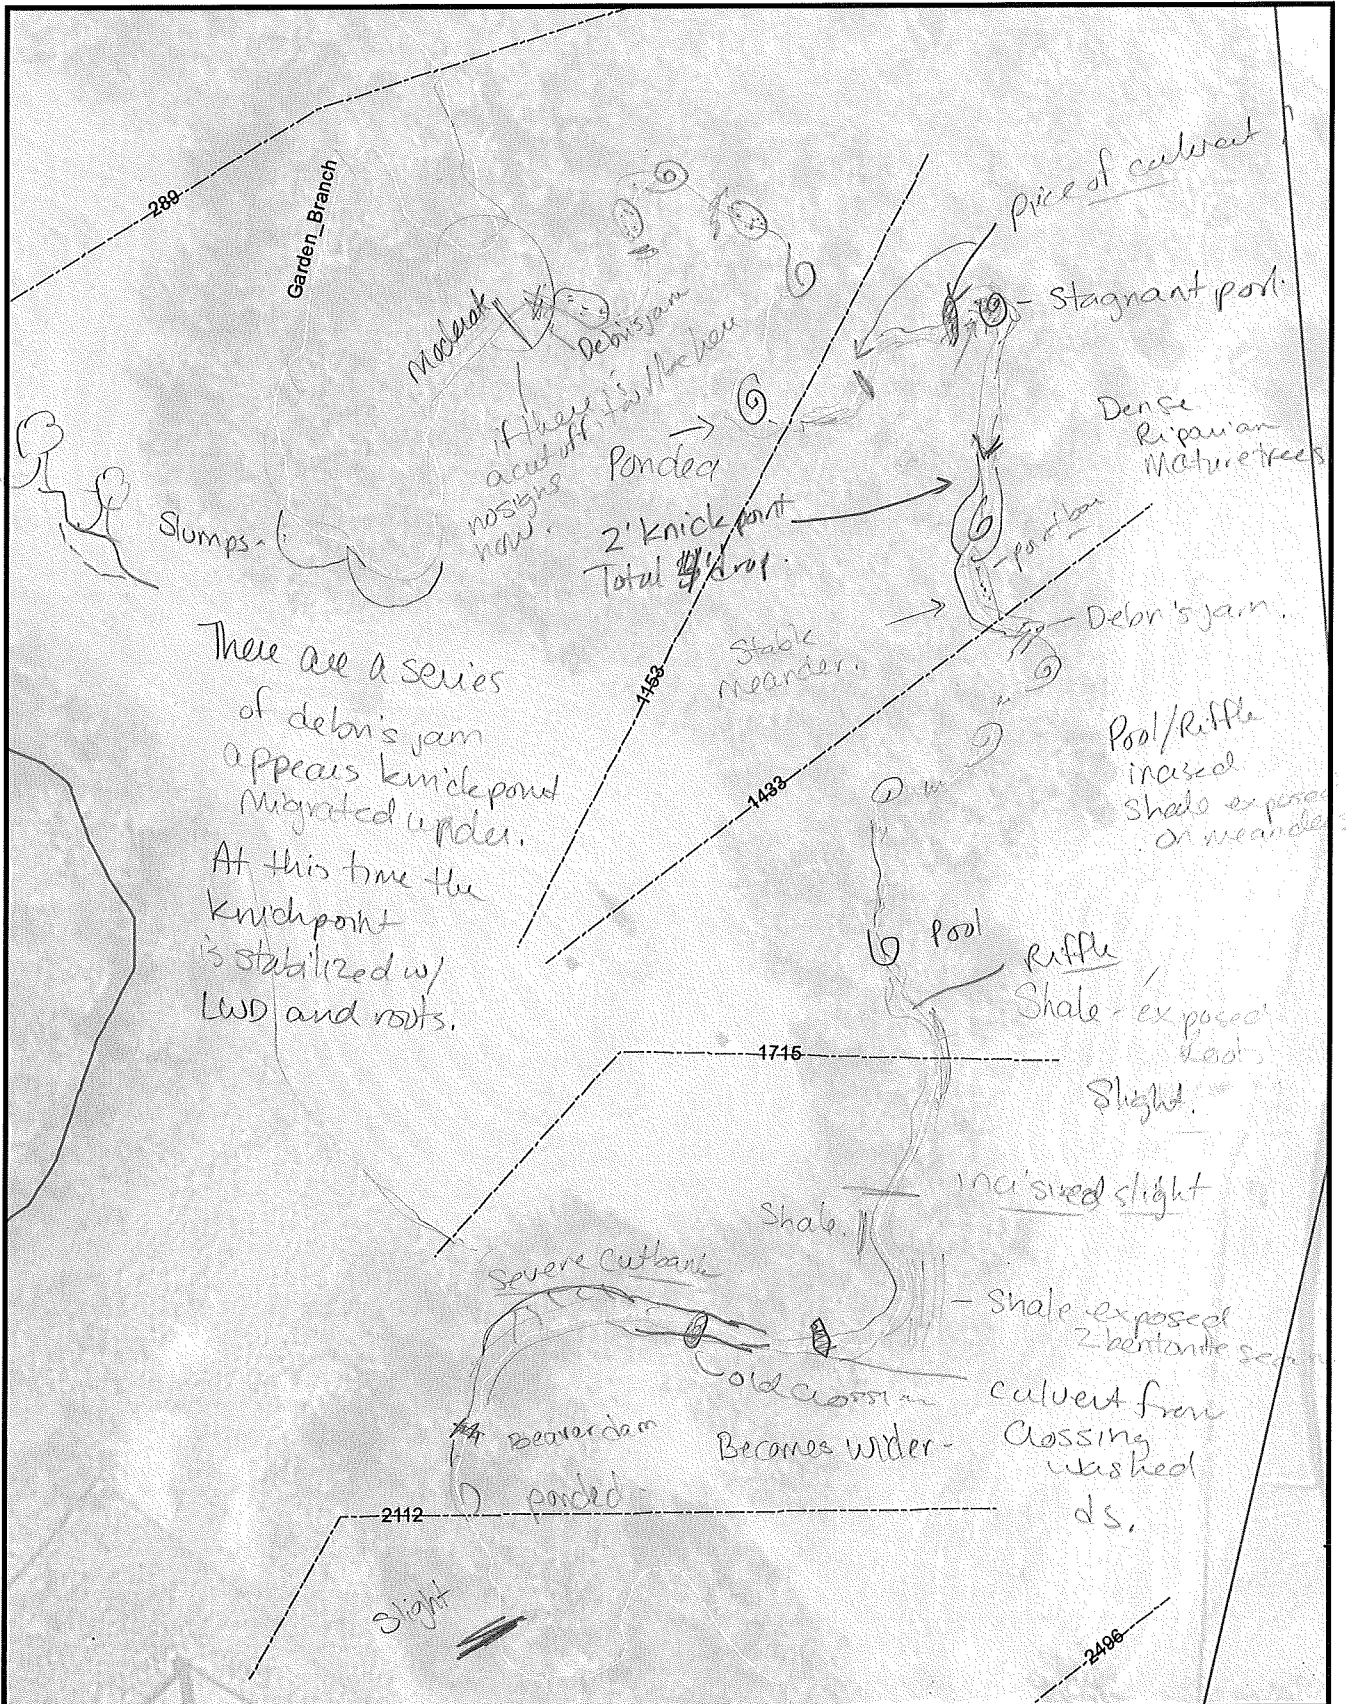
There are a series of debris jam appears knick point migrated updr. At this time the knick point is stabilized w/ LWD and roots.
