City of Grand Prairie Drainage Master Plan for Johnson Creek Corridor

City Project No. Y#0948

April 2014

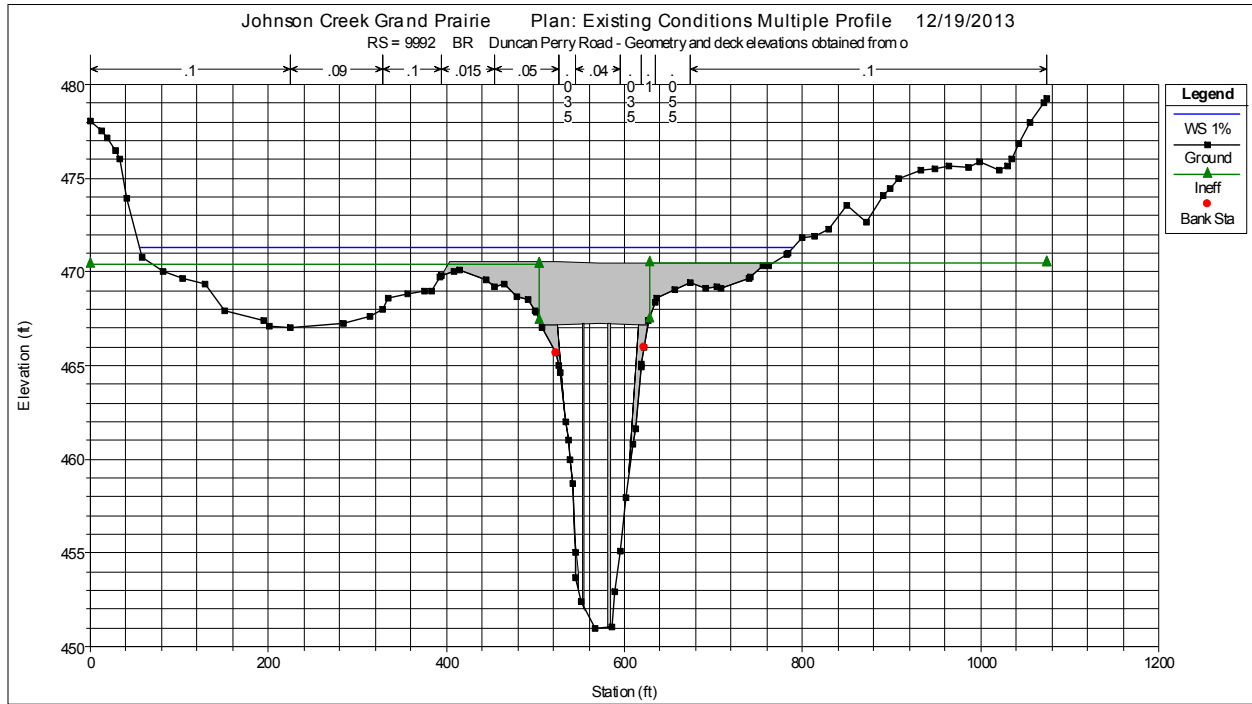
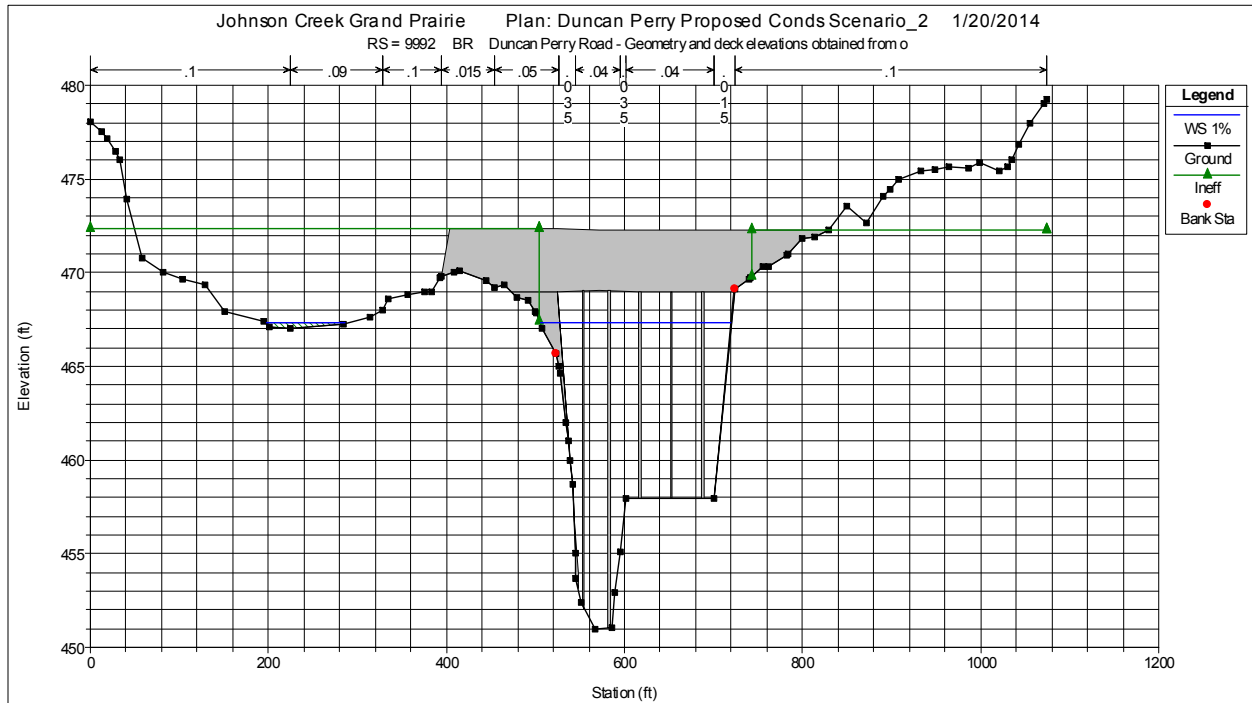
Existing Conditions Duncan Perry Road

Duncan Perry Road Alternative Cross Section View

Figure VII-2. Duncan Perry Cross Sections for the 1% Annual Chance Flood Capacity

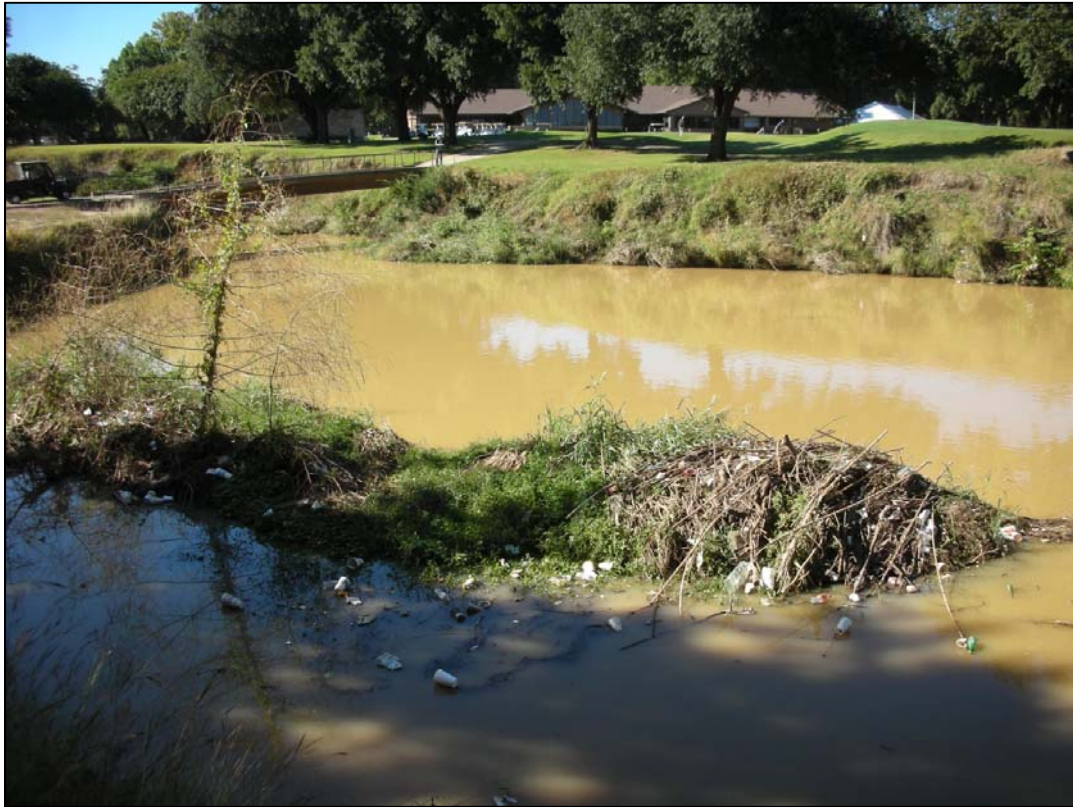
Photograph IX-1: Photograph of Point Bar Located Downstream of Cross Section 17044.

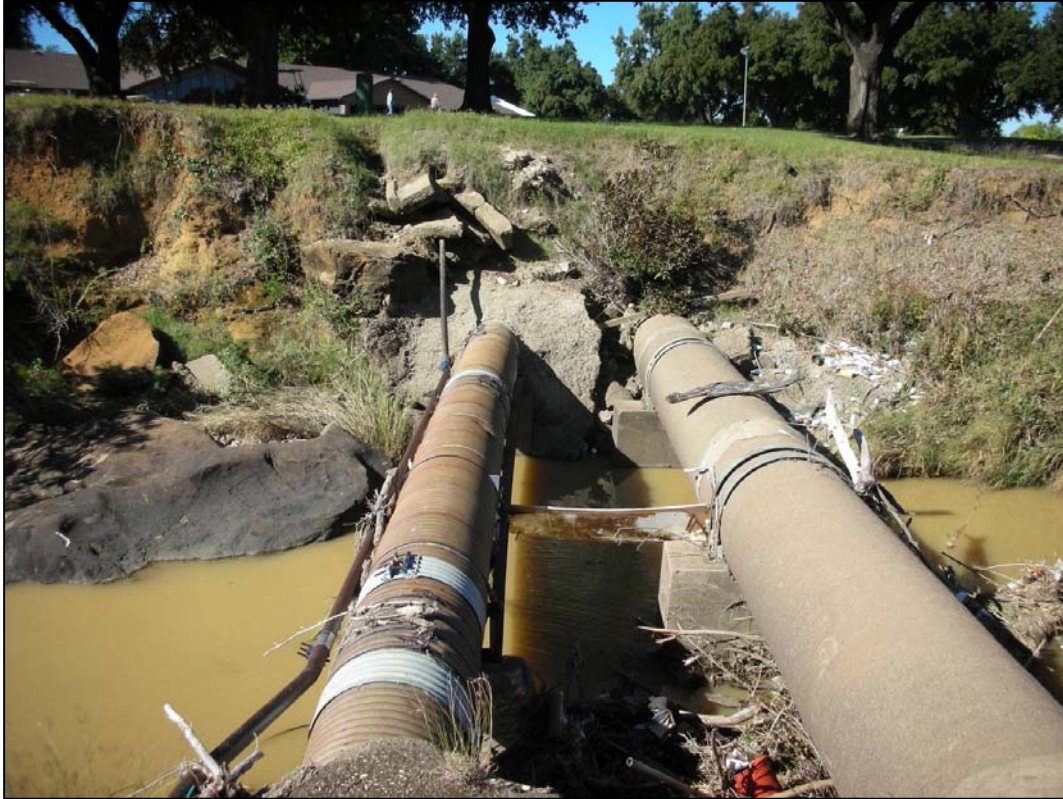
7. A golf course bridge and aerial crossing are located immediately downstream of the on channel pond from cross section 16892 to 16816 as shown on **Figure IX-4.1**. No scour is observed along the bridge, but significant abutment scour including concrete slab failures are observed on the right side of the aerial crossing. **Photograph IX-2** shows the slope and concrete failures.

Photograph IX-2: Slope and Concrete Failure at Aerial Crossing #2

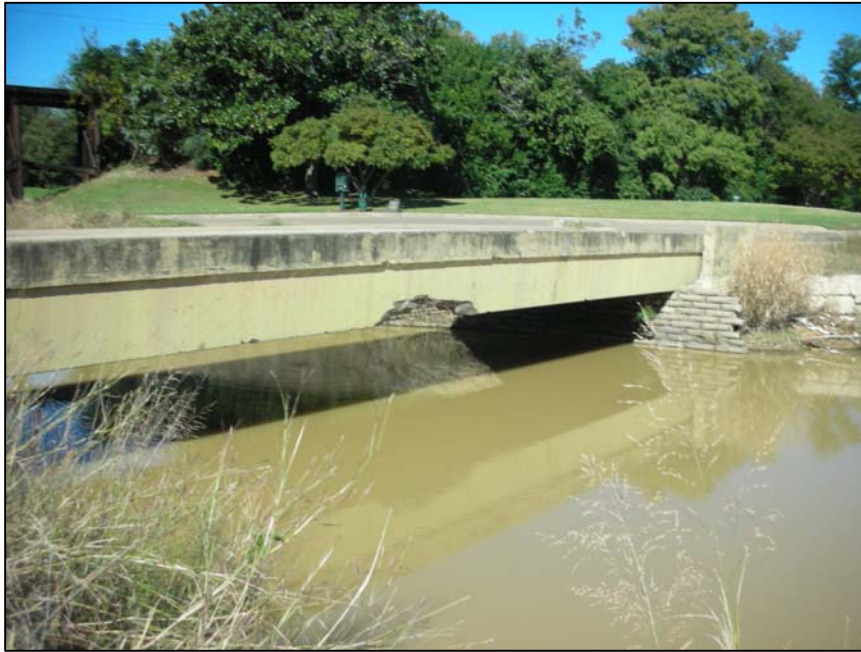
8. Beginning immediately downstream of the aerial utility crossing at cross section 16816 and continuing to the Union Pacific Railroad Bridge, riffle-pool sequencing becomes reestablished in the channel with an average riffle to pool spacing of approximately 140 feet as shown in **Figure IX-4.2** photo 008.
9. Despite the large contraction, significant scour is not observed in the field at the Union Pacific Railroad Bridge. However, a deep scour pool is evident on aerial photographs downstream of this feature shown in **Figure IX-4.2** photo 009.
10. Approximately 160 feet downstream of the Union Pacific Railroad Bridge, a golf cart path crosses the creek at cross section 15829. Scour is not observed here, but a significant portion of the downstream end of the concrete beam spanning the bridge is damaged as shown in the photograph in **Photograph IX-3**.

Photograph IX-3: Concrete Span Damage at Golf Course Bridge #4

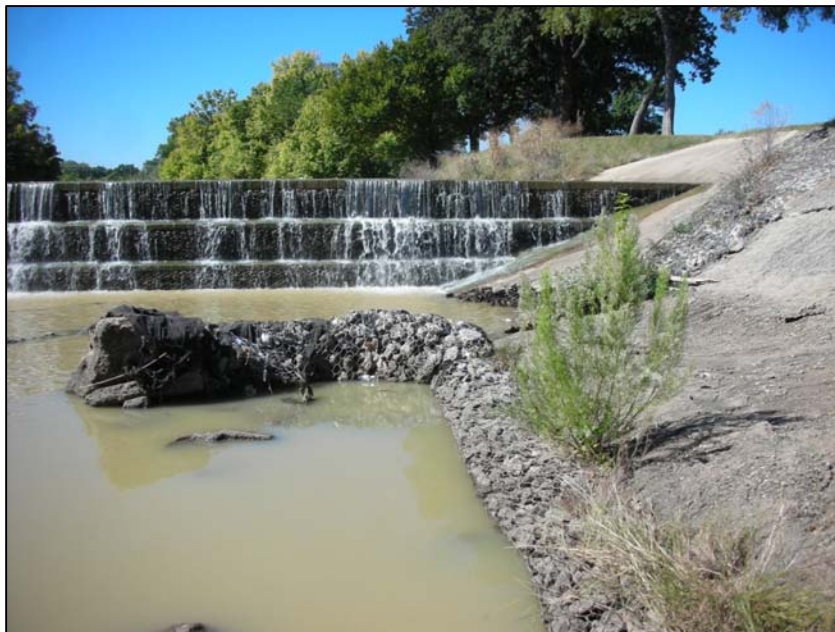
11. Between cross sections 15780 and 14839, a wide and deep pool is formed by an inline grade control structure made of gabion blocks at the downstream end of this feature as shown on photo 011 on **Figure IX-4.2**.
12. Significant failure of gabion mattresses is observed on the left bank continuing approximately 225 feet downstream of the inline structure from cross section 14839 as shown in **Photograph IX-4** below. **Figure IX-4.3** outlines the length of the gabion failure on the aerial photo.

Photograph IX-4: Gabion Mattress Failure at Inline Structure #2

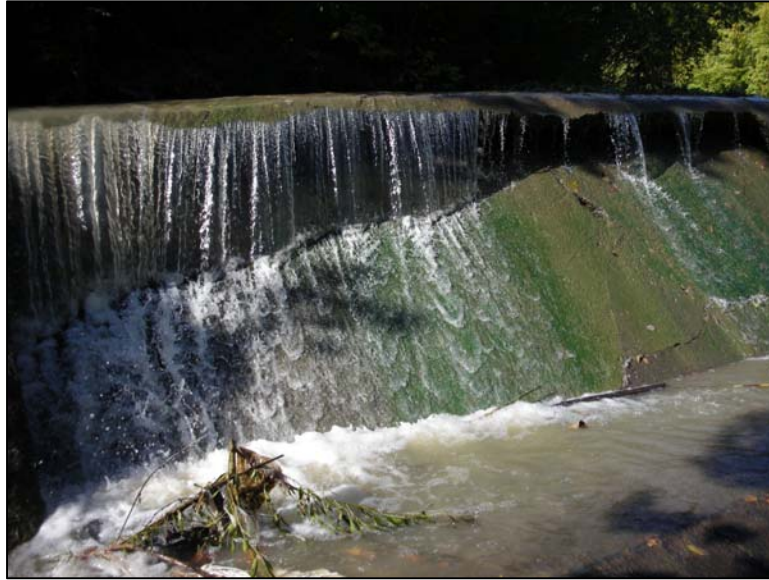
Photograph IX-5: Concrete Failure on Downstream Side of Inline Structure #3

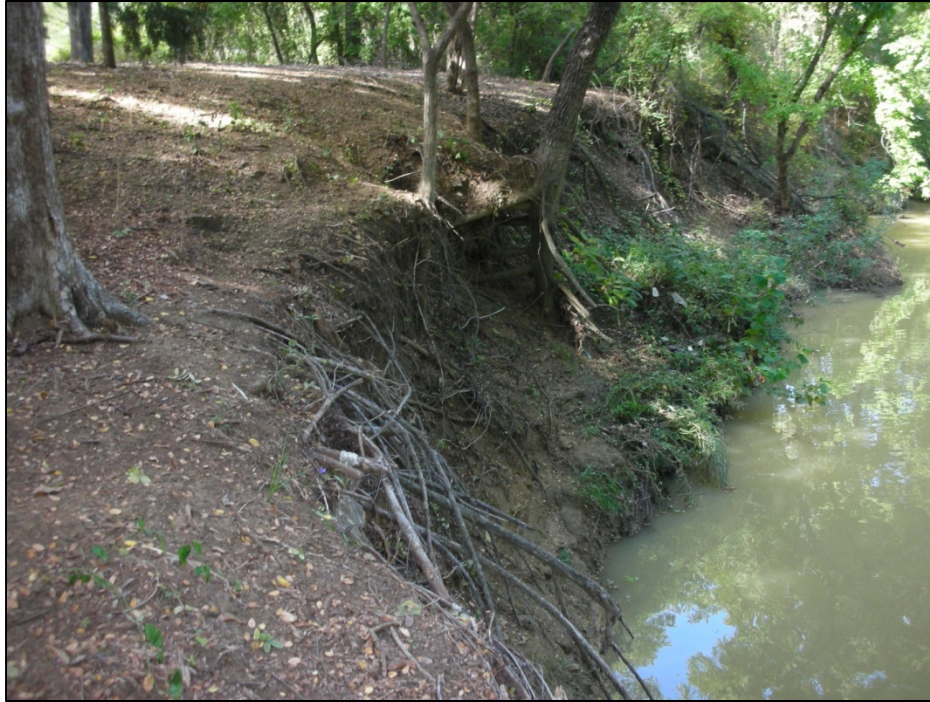
Photograph IX-6: Bank Cuts on the Right Bank in the Middle of Reach 3

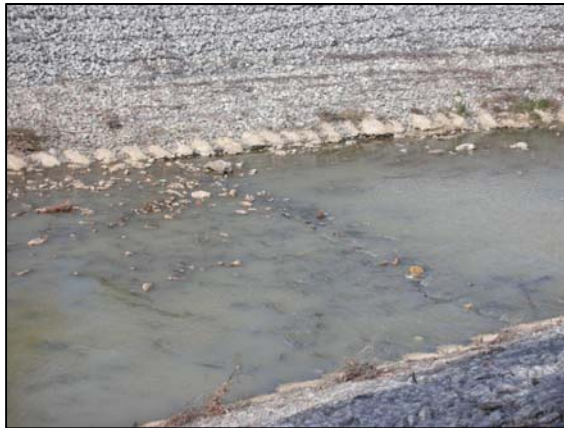
Photograph IX-8: Relatively Clear Water Flowing Downstream

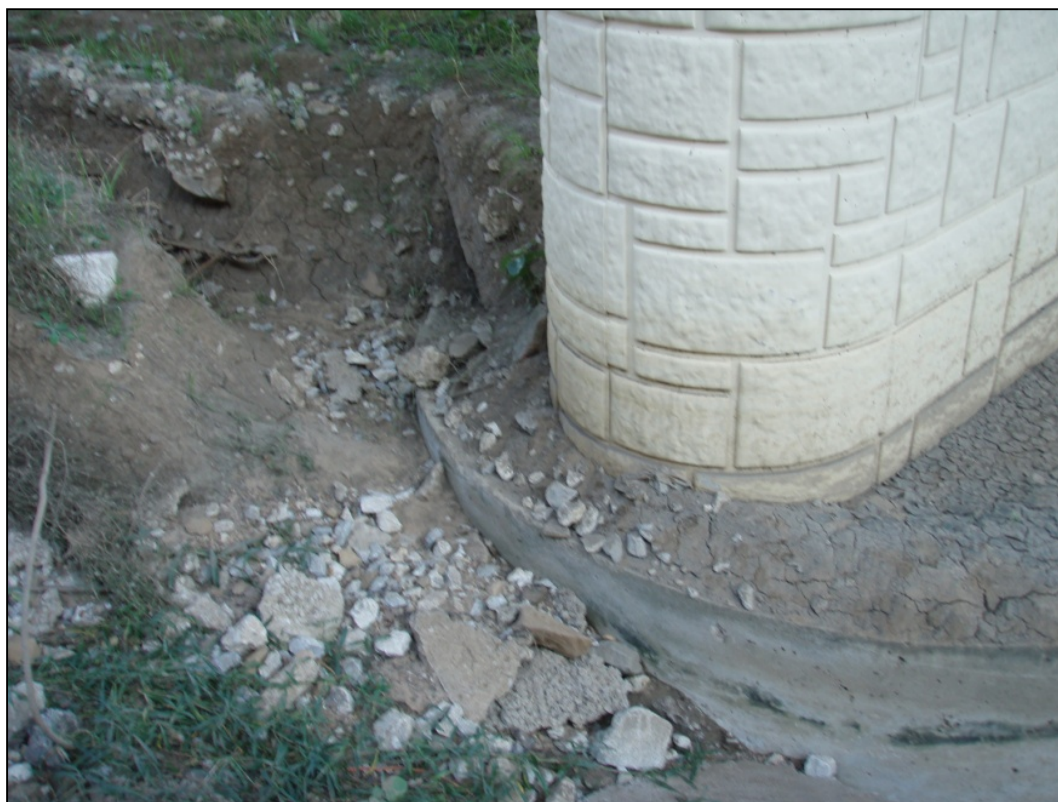
Photograph IX-9: Pier Scour at SH 161 Caused Footing to Become Exposed

The stream stability projects are intended to minimize the effects either erosion or deposition have on the functionality and conditions of structures along and adjacent to the creek. Three key locations have been identified as susceptible to significant scouring. In these cases, either scouring is either currently observed or is likely to occur at State Highway (SH) 161, the Union Pacific Railroad crossing and Avenue J. To mitigate the existing and future scours under SH 161, a detailed scour analysis and stabilization measures are recommended.

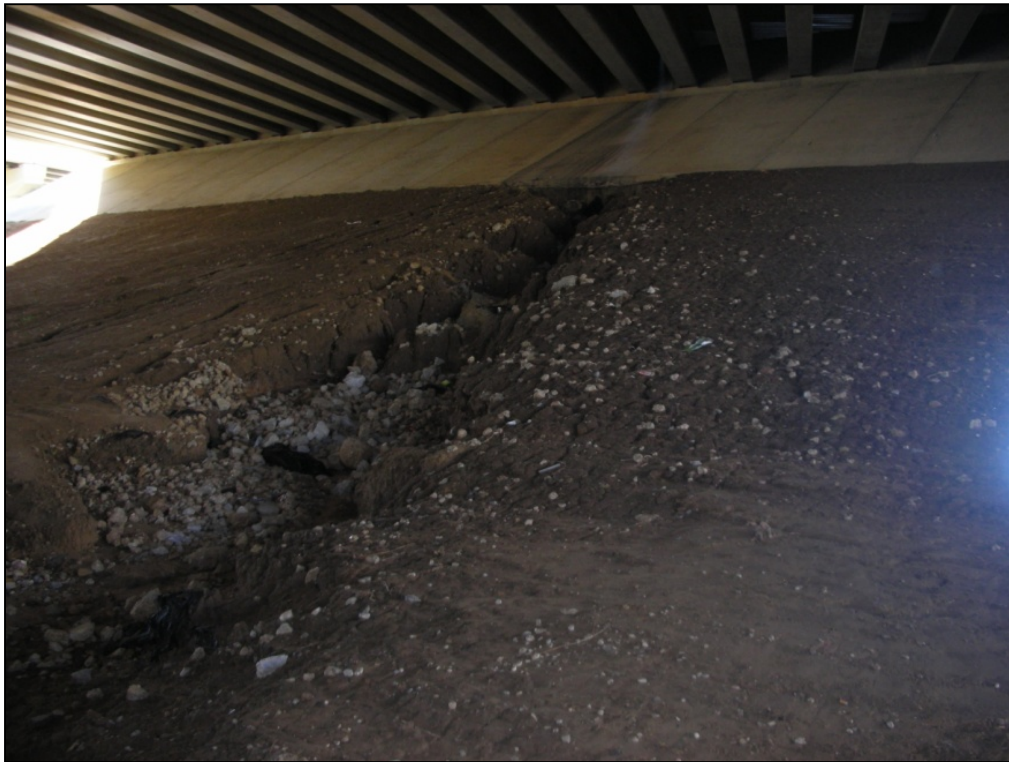
Photograph IX-10: Erosion Caused by Roadway Runoff Seeping through SH 161 Crossing

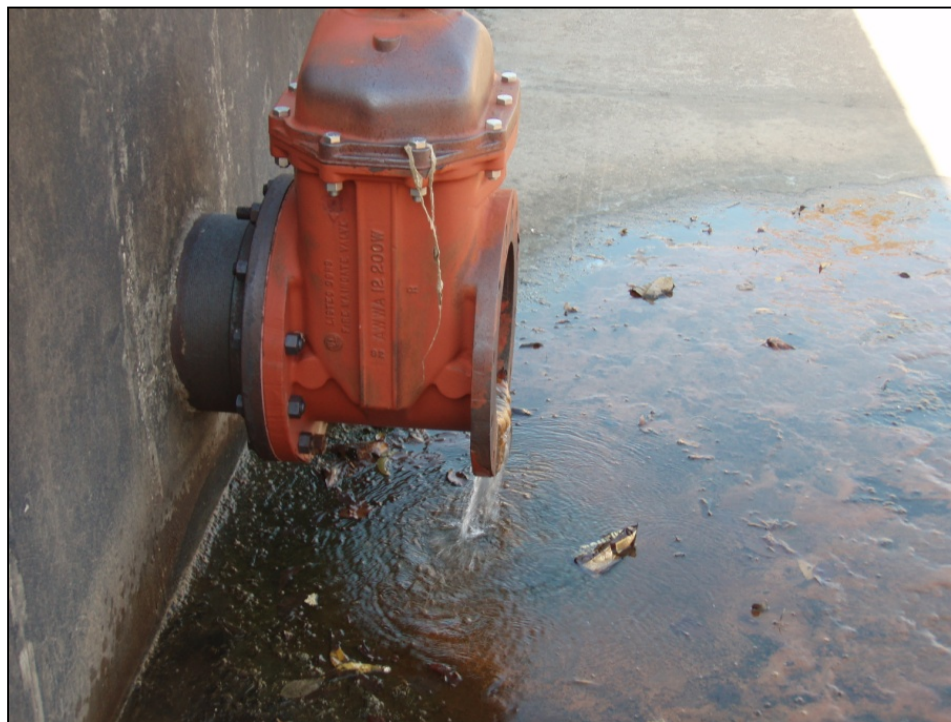
Photograph IX-11: Water control Valve on Downstream Side of Inline Structure #5. Valve is fully opened but is clogged with sediment

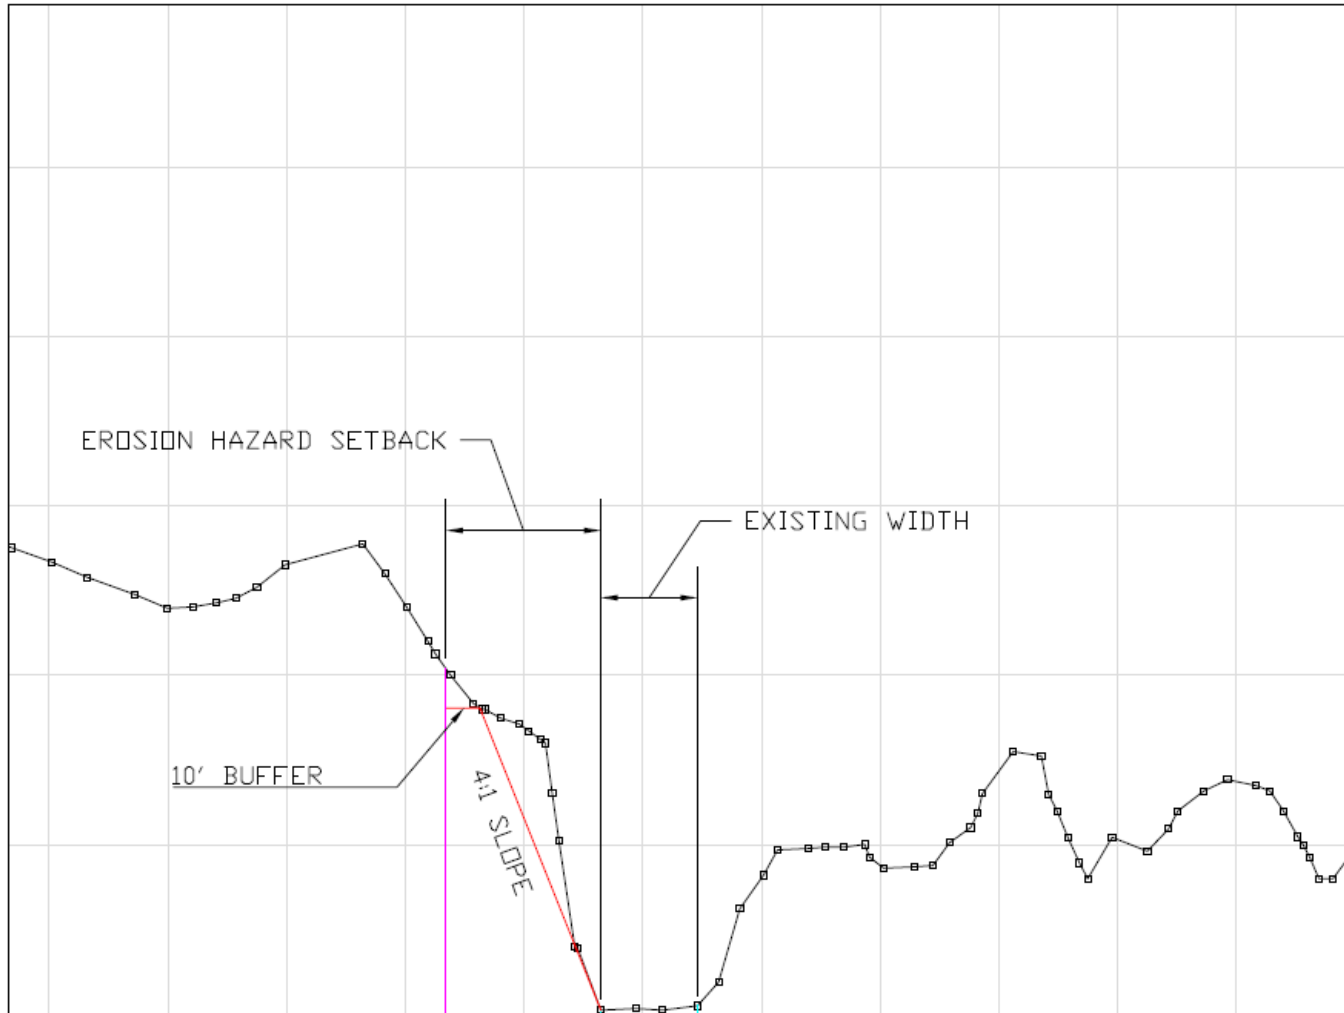
Erosion Hazard Setback at Section 12931

Figure IX-9. Determination of Erosion Hazard Setback

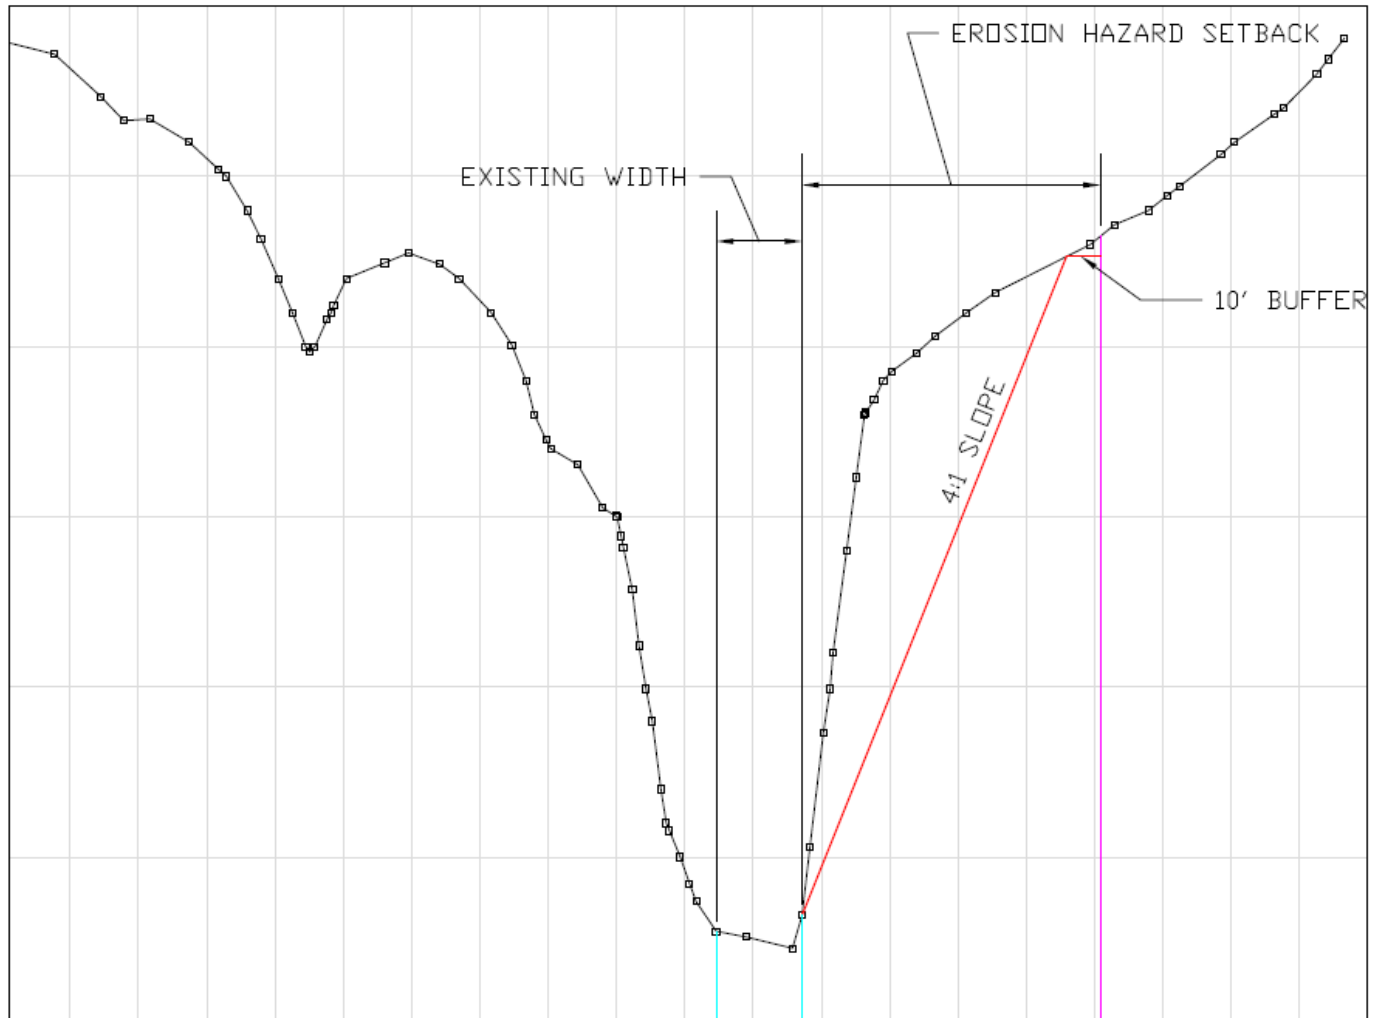
Erosion Hazard Setback at Section 10809

Figure IX-10. Determination of Erosion Hazard Setback
