City of Grand Prairie Supplemental City-Wide Drainage Master Plan for Fish Creek (Y#0882) Garden Branch, Kirby Creek, & Willis Branch

February 2013

Garden Branch Stream Condition Assessment

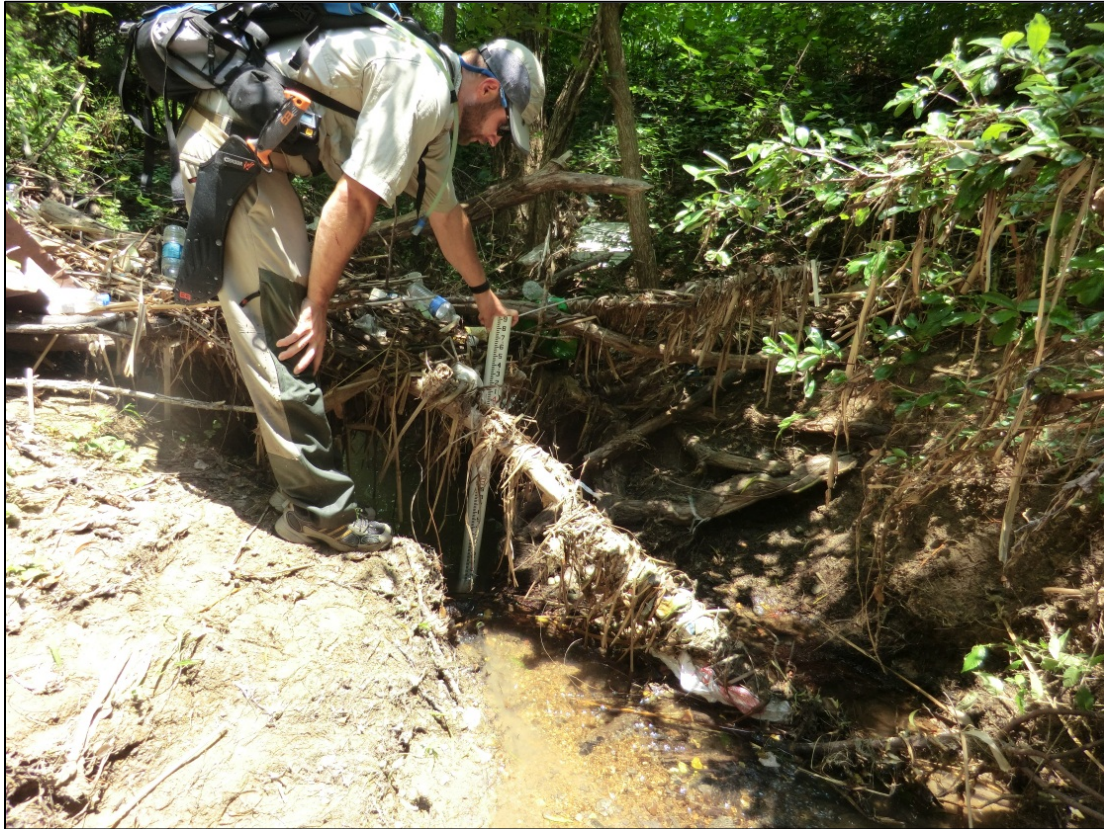
Figure 4.3 Looking downstream near cross section 3491 at a knickpoint with a 2-foot drop in elevation.

Knickpoint Location	Description and Movement
Between XS 6348 and 6056	The knickpoint had a total drop in elevation measuring approximately 1.5 feet. Field observations suggest minimal migration exposing tree roots.
Between XS 3491 and 3177	Near cross section 3491, there was a knickpoint with a two-foot drop in elevation. The location contained a debris jam. Field observations suggest that this knickpoint has the potential migrate upstream with higher flows. The second knickpoint was located approximately half way between cross section 3491 and 3177. The knickpoint had an approximately one-foot drop in elevation.
Downstream of XS 1433	There were two knickpoints spaced eight feet apart. The total drop in elevation measured about 4 feet. The knickpoints were directly downstream of a beaver dam. Observations suggested that beaver dams existed at the locations of the knickpoints, but were undercut as the knickpoint migrated upstream. Field observations also indicated active knickpoint migration at this location.

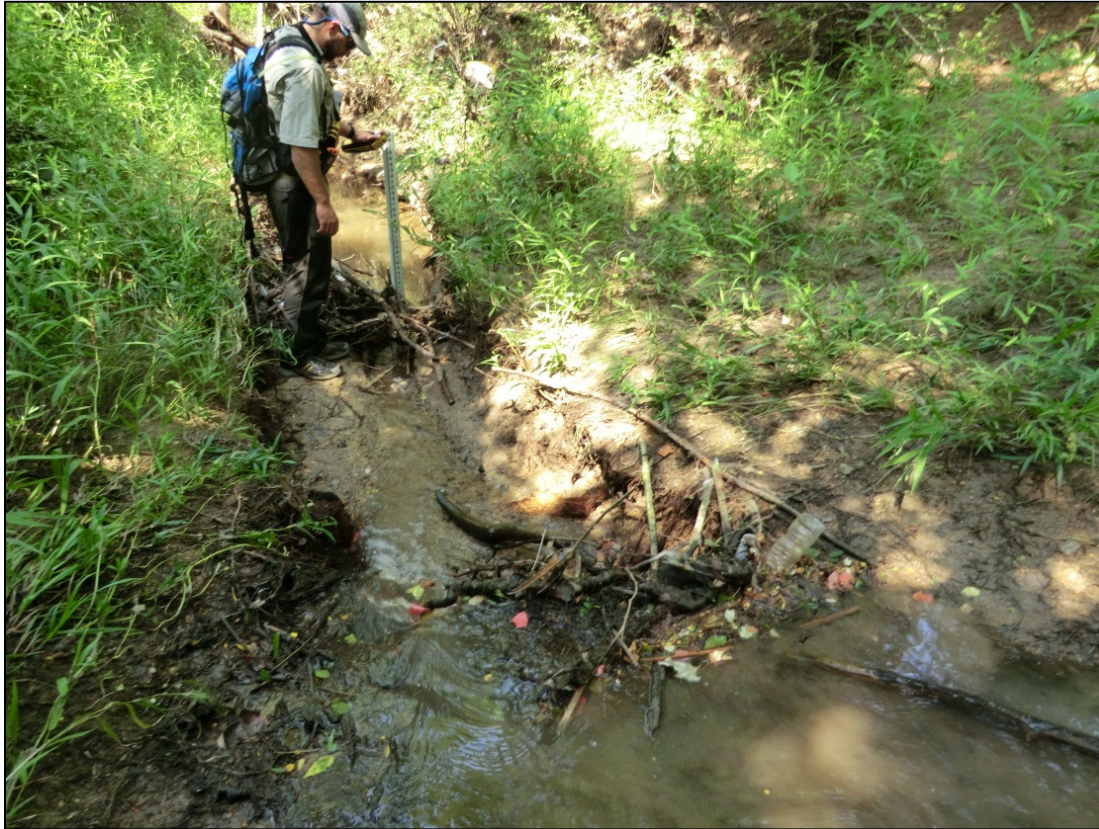
Figure 4.4 Looking downstream near cross section 1433 at a series of knickpoints. Total drop in elevation was 4 feet.

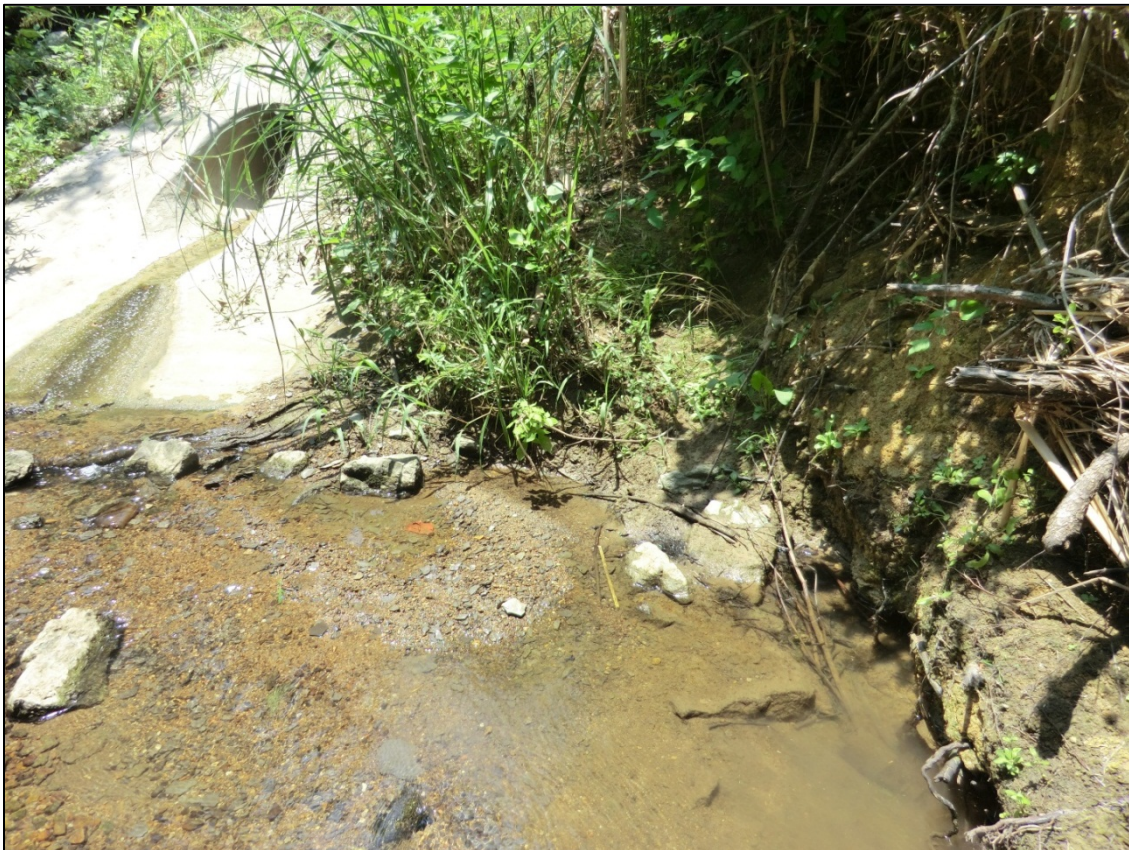
The first moderate erosion location was downstream of an outfall on the left bank near cross section 3491. The left bank was scoured by the erosive flows from the outfall. The bank lacked sufficient erosion control (Figure 4.6). The eroding bank was not threatening infrastructure, but was contributing sediment from erosion.

Figure 4.6 Looking upstream at bank erosion near cross section 3491

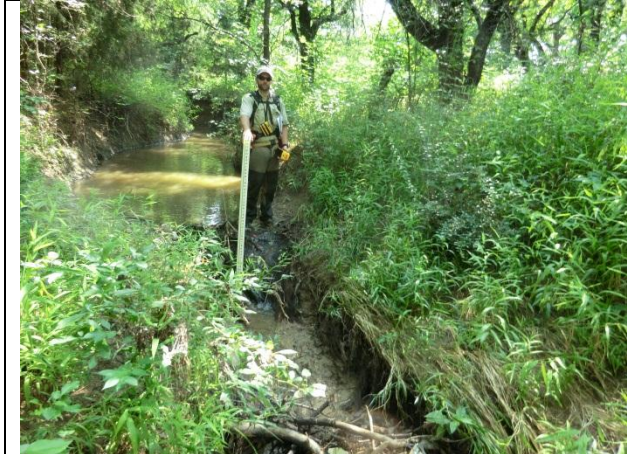
Downstream of 1433 there was a series of knickpoints migrating in the upstream direction.

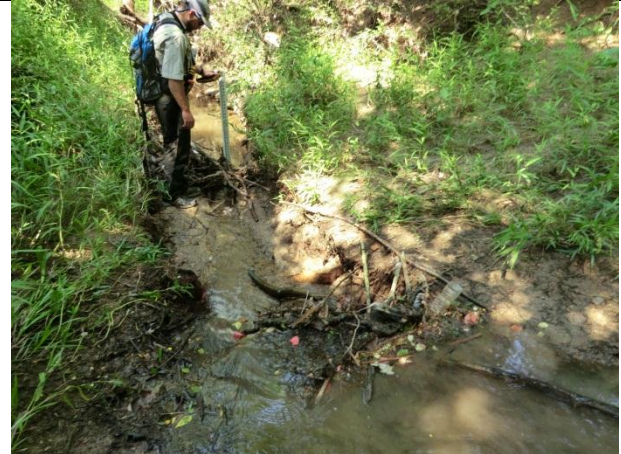
Downstream of 1433, looking downstream at the series of knickpoints, total drop was about 4 feet.

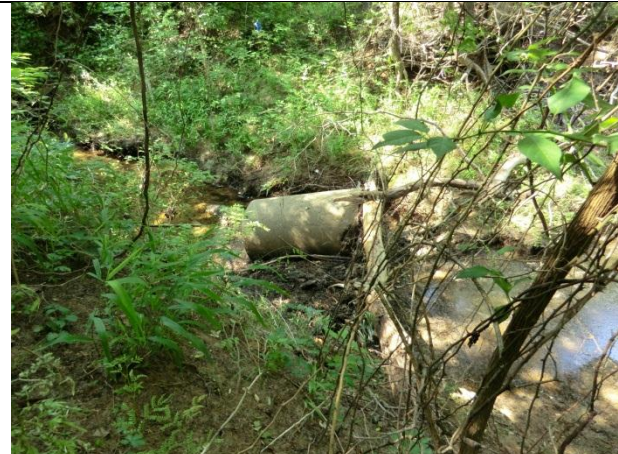
Upstream of 1153 there was a debris jam around a segment of concrete pipe.

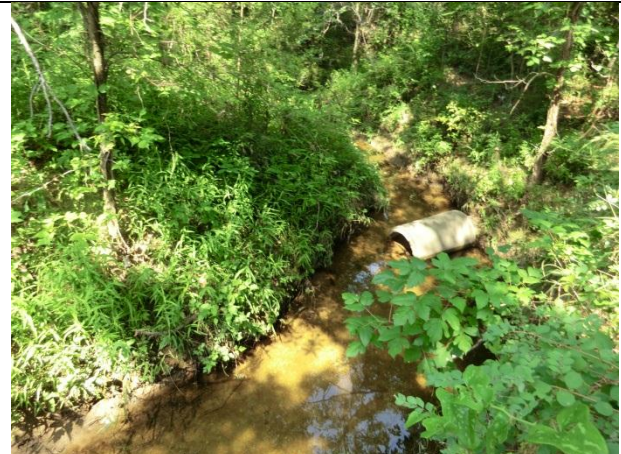
Looking upstream from 1153 there was a second segment of concrete pipe.

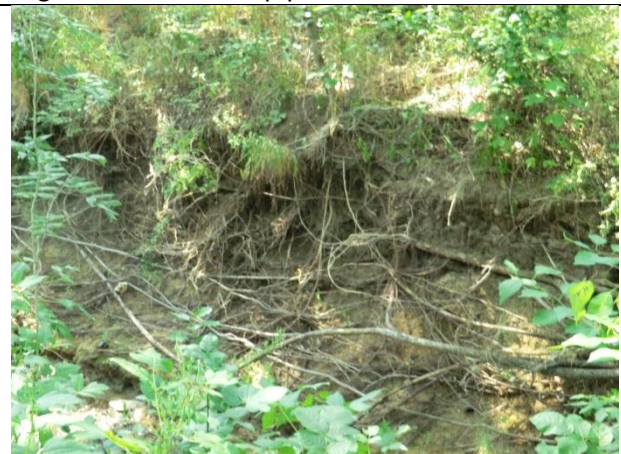
Right bank downstream of 1153 the banks are actively eroding.
