City of Grand Prairie Supplemental City-Wide Drainage Master Plan for Fish Creek (Y#0882) Garden Branch, Kirby Creek, & Willis Branch

February 2013

Garden Branch Stream Condition Assessment

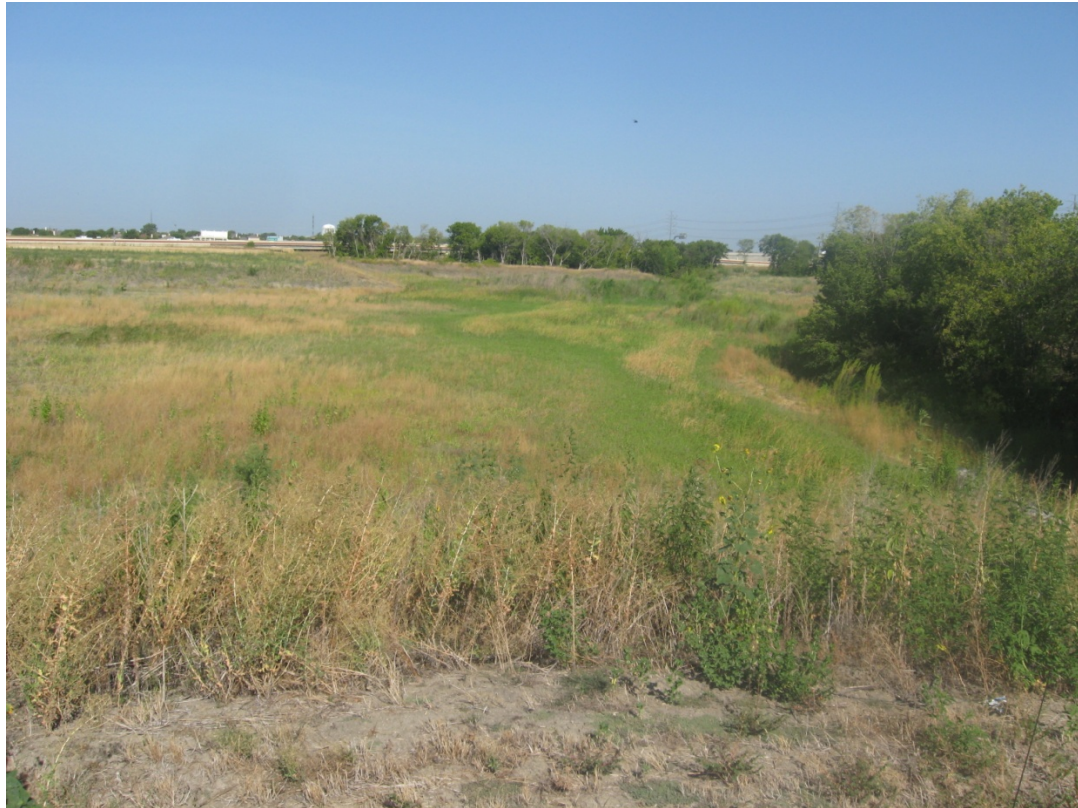
Figure X-1 – Regional Detention Pond Along Kirby Creek

One (1) regional detention pond located along Kirby Creek just west of Robinson Road was not included within the City-wide Drainage Master Plan for Fish Creek. This regional detention pond was proposed by Halff Associates as part of the 2006 Capital Improvement Study along Kirby, Prairie and Fish Creek Drainage Basins to reduce peak discharges downstream. Figure X-1 below shows a picture of the regional detention pond taken by Halff Associates in August 2012 during a field inspection of Kirby Creek.

Refer to Section X of the City-wide Drainage Master Plan for Fish Creek prepared by RPS Espey Consultants for maintenance recommendations for detention ponds located within the Garden Branch, Willis Branch, and Kirby Creek watersheds. Halff Associates performed a visual inspection of the regional pond located along Kirby Creek just west of Robinson Road in August 2012. The regional pond was in good condition and no corrective maintenance is needed at this time. Halff recommends continued regular inspections of the regional detention pond.

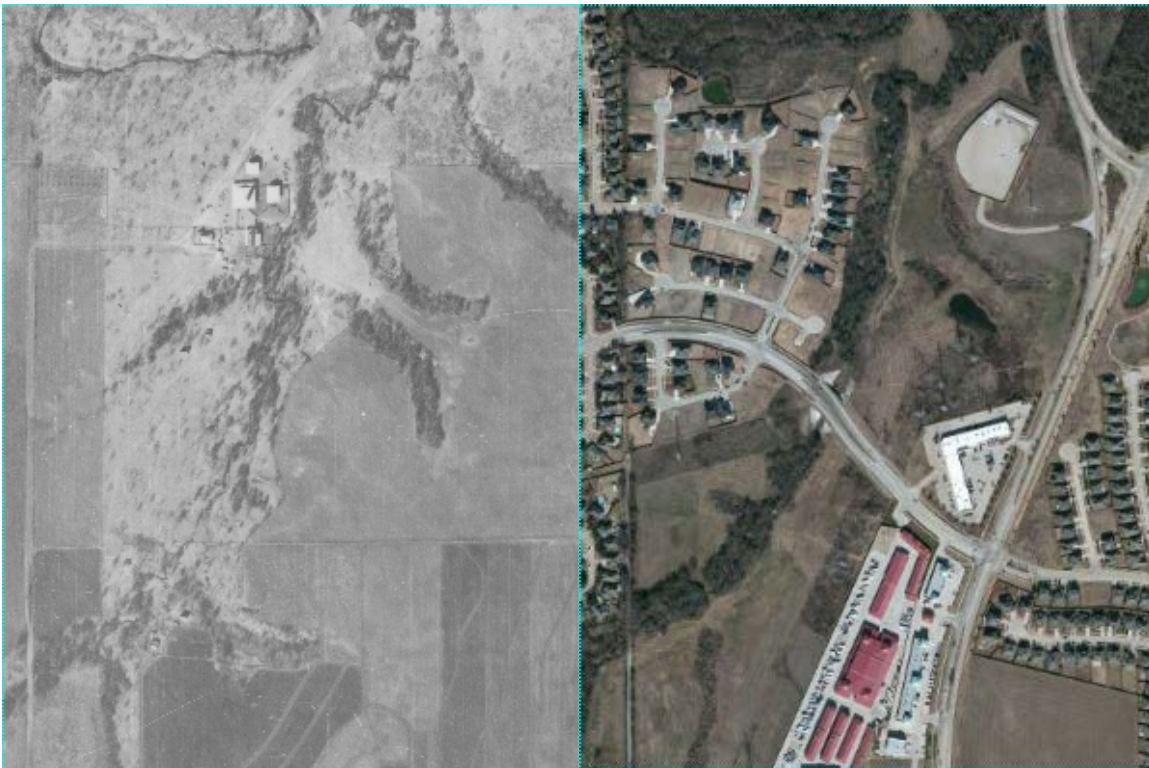
Figure 4.1 Historical aerial photographs from 1942 and 2011

In 1942 (Figure 4.1), the surrounding land adjacent to Garden Branch was rural pasture land. The photograph shows a non-developed buffer containing the tributary channel. In 1996, the historical photograph showed development within the watershed. In 2011, the portion of the watershed immediately adjacent to the channel had remained agricultural. Since the 1940's Garden Branch has had a riparian corridor that has continued to mature.

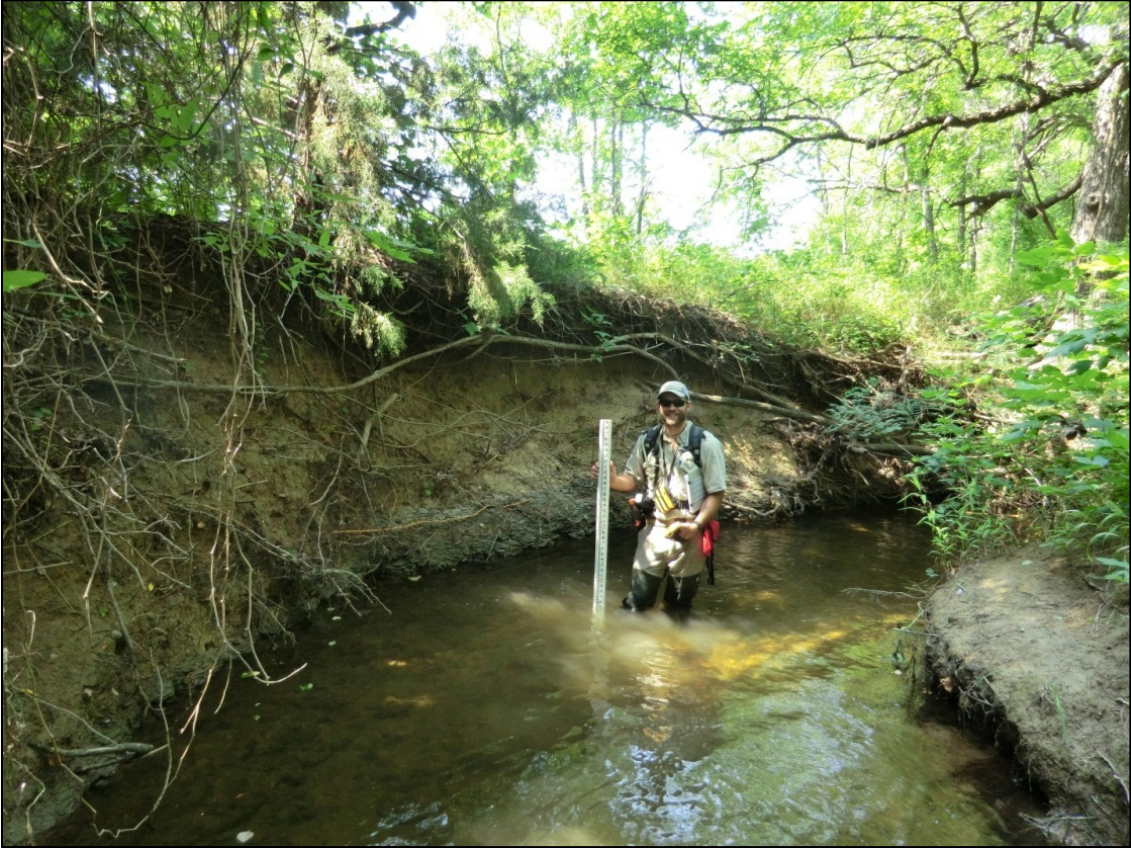
Figure 4.11 Looking Upstream at exposed shale on a meander in Garden Branch

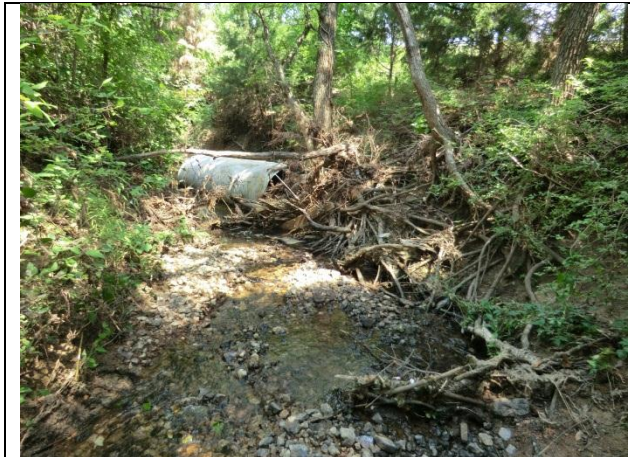
<p>Downstream of 2112, there was a metal culvert blocking the channel; it eroded out from a water crossing location.</p>	<p>Upstream of 2112, the right bank was slumping and showed soil creep.</p>

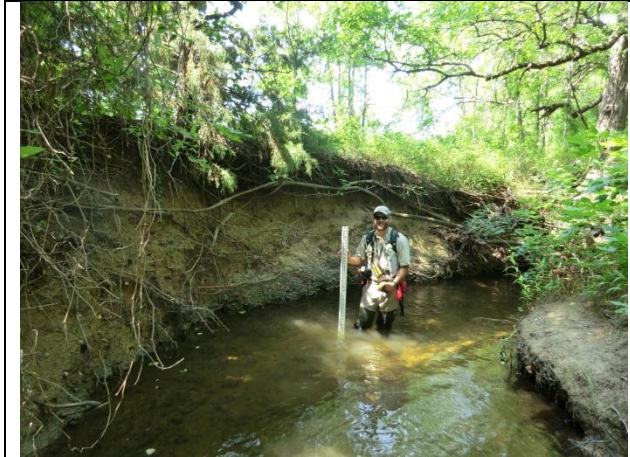
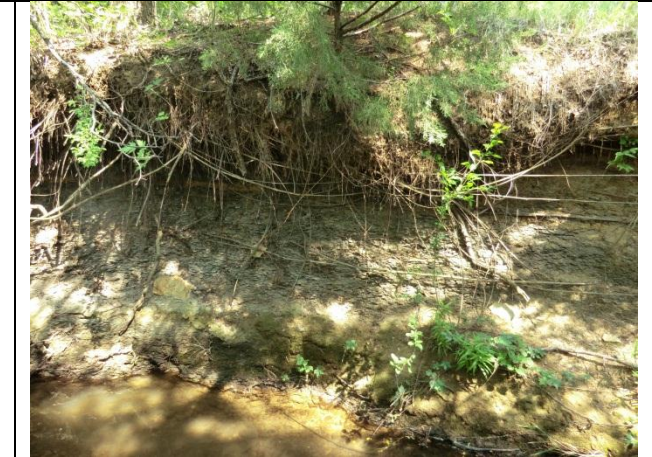
<p>Upstream from 1715, eroded right bank exposing shale.</p>	<p>Right bank at 1715, shows the e</p>

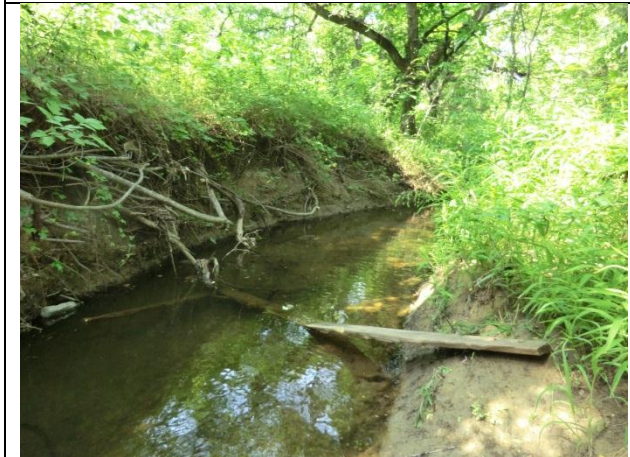
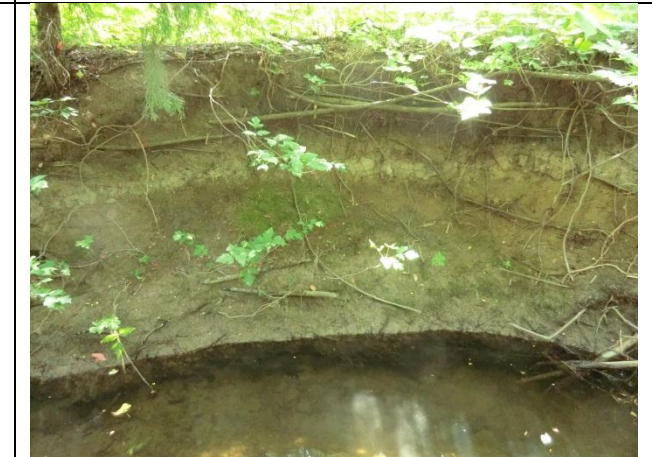
<p>Upstream of 1433, incised channel.</p>	<p>Left bank at 1433 shows a stable cutbank.</p>
